USAAMRD TECHNICAL REPORT 72-1

WIRE-BRAIDED HOSE CHAFING TESTS

Donald R. Artis, Jr.

January 1972

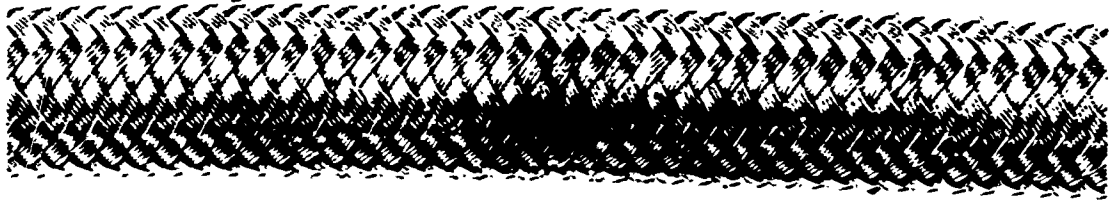
Figure 57. Test Specimen 42AC (100,000 Seconds Test Time).
